REGULAR MEETING OF THE MUNICIPAL SERVICES COMMITTEE TO BE HELD ON MONDAY, OCTOBER 14, 2013, AT 6:00 P.M. AT THE VILLAGE HALL, 7760 QUINCY STREET, IN THE VILLAGE OF WILLOWBROOK, DUPAGE COUNTY, ILLINOIS.

## Executive Elevated Tank Observation Report

## 67th Street Elevated Tank Observation Report

## Standpipe Observation Report

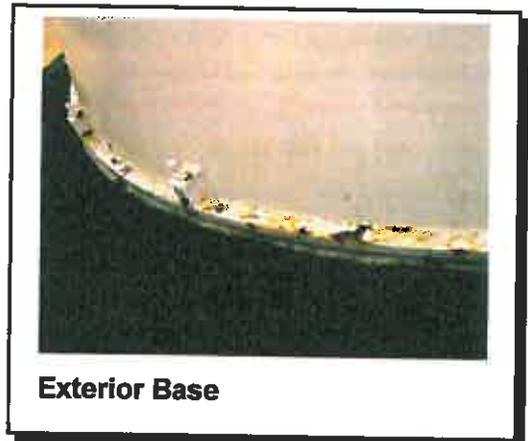
Overall, the foundation is weathered but appears to be in good condition. There are no indications of differential foundation settlement. No soil is eroded nor is there visible undermining of the foundation. The concrete ring wall extends 2 to 3 inches outward from the grout surface.

The tower rests on a concrete foundation. The elevation of the top of the foundation varies from 3 to 4 inches above grade in the north to at grade on the east, west, and south portions. The concrete foundation exhibits minor spalling. The grout at the base appears to be in overall good condition with a few instances of minor spalling.

Most of the 18 anchor bolts exhibit corrosion. The bolts are 1 3/4-inch diameter with 4 3/4-inch by 6 1/4-inch chairs.

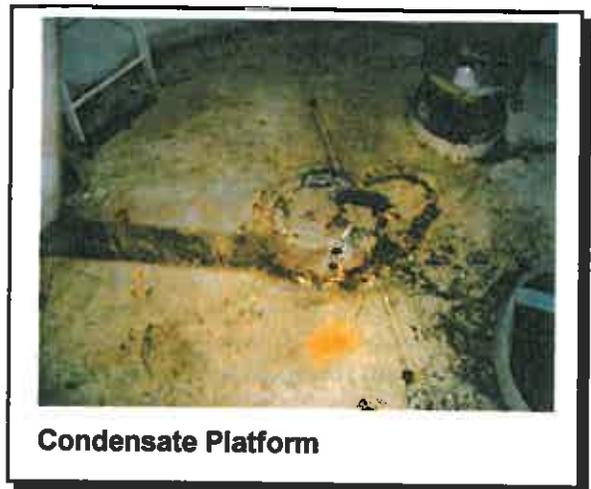
**Condensate Platform**

Cellular cable penetrations are protected by a 4-inch-tall curb on the floor of the platform. The curb is welded to the floor on all sides, and damage to the coating has not been repaired.

The light immediately above the condensate platform is not operational.

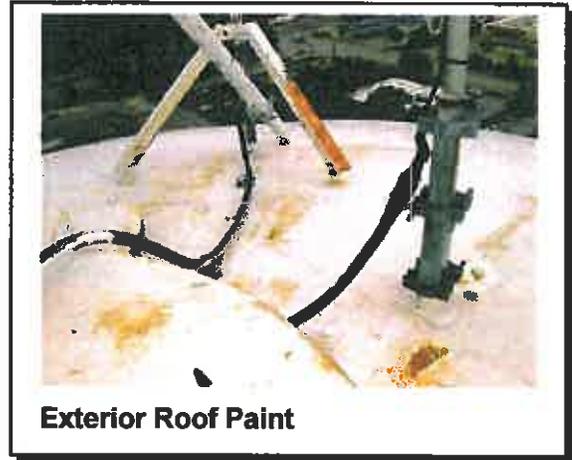
The top of the tank appears in poor condition. The clear coat and the remaining coatings have failed in multiple locations and significant rusting is present. The top of the tank averages 4 to 7 mils of coating thickness. The adhesion of coating on the roof appears fair to poor.

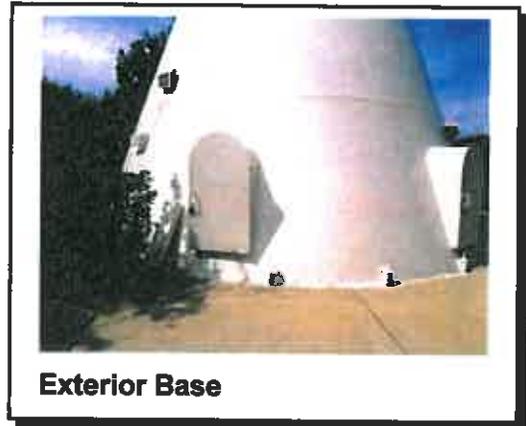
Exterior Base

The tower rests on a concrete foundation. The elevation of the top of the foundation varies from 1 inch above grade in the north to 4 inches above grade in the west to at grade in the south and east. The foundation, where observed, appears weathered but in good condition. There is minor spalling in the northwest corner. The grout at the base appears to be in good condition but has minor spalling in the north and west portions of the base cone.

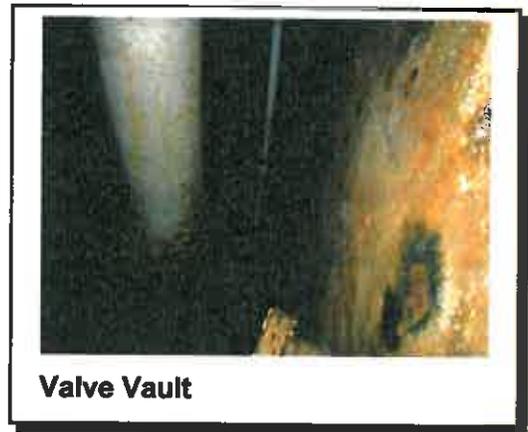
Valve Vault

The water main enters the valve vault from the southeast and appears to be 12 inches in diameter. The vault is secured by steel/aluminum grating. The piping is in fair condition and appears to have significant rusting. The flanges and fittings appear in very poor condition.

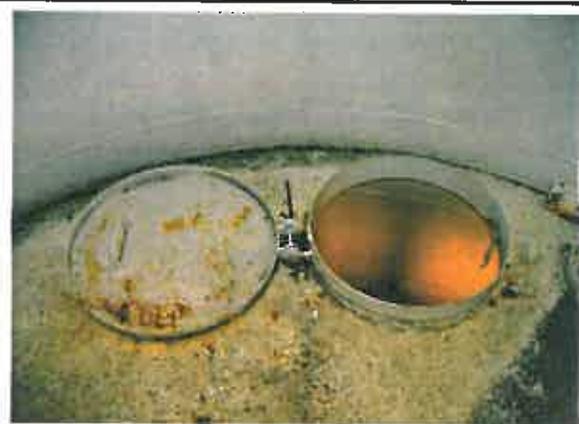
Floor of Condensate Platform

The condensate platform appears in good condition. The hatch and manway show some corrosion and there is a rectangular weld seam (approximately 4 square feet) that has corrosion on both sides of the platform. The walls immediately above and below the platform are in good condition with very little or no corrosion visible.

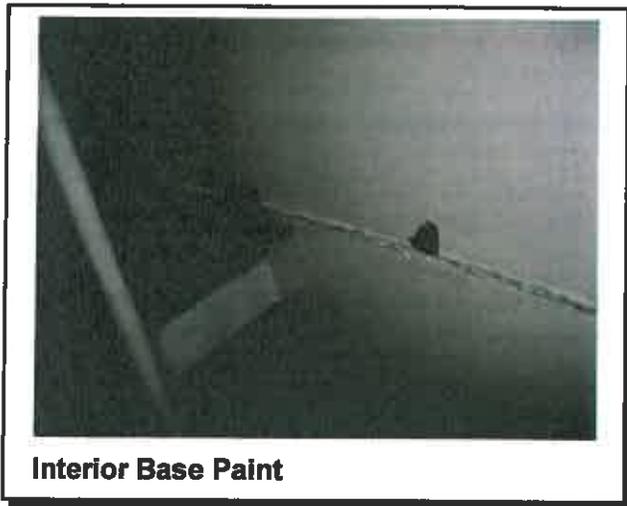
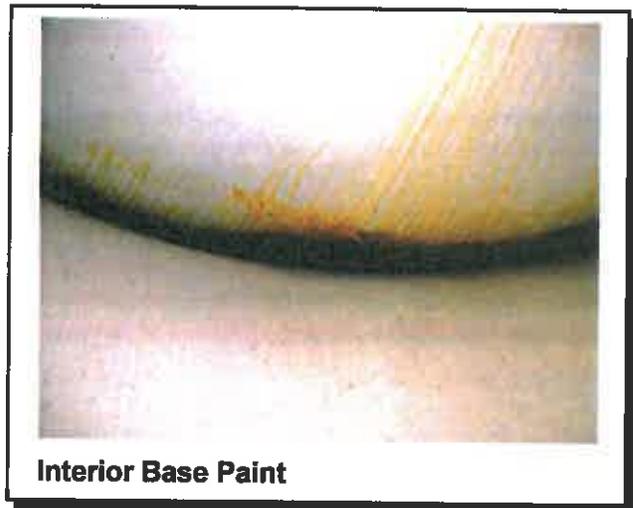
The interior dry between the wooden platform and the condensate platform had significant coating delamination of the top coat. It appears an overcoat over aluminum was done. The coating is peeling off and can be peeled back with very little effort along the weld seam and side of the stem and base cone. Epoxy will not adhere well to an aluminum coating system. This does not match the specifications that were provided for this tank.

There are coating failures on the pipes and valves. The average coating was 8 to 11 mils but significant corrosion was exhibited.

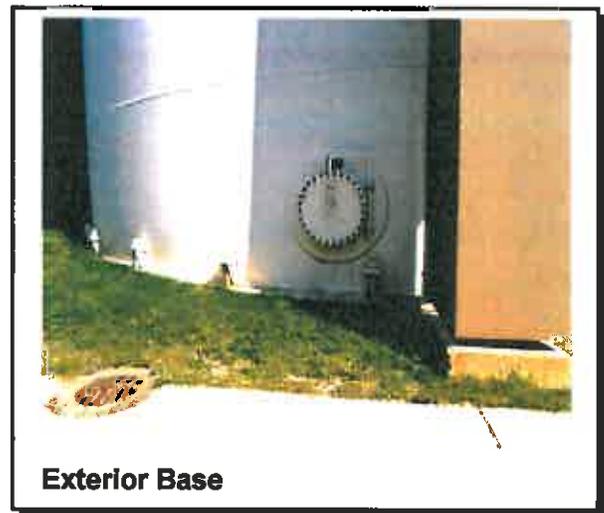
Exterior Base

The tower rests on a concrete foundation. The foundation is exposed on the south side approximately 3 to 5 inches but is at grade on all other sides. The south side foundation is weathered but appears in good condition. The grout is spalling on the west side of the standpipe but appears to be in good condition on all other sides.

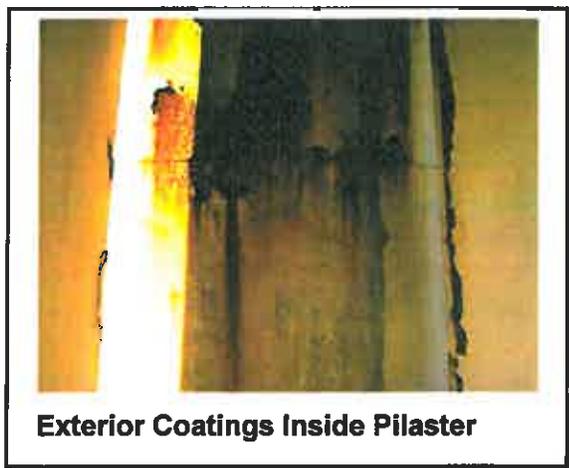
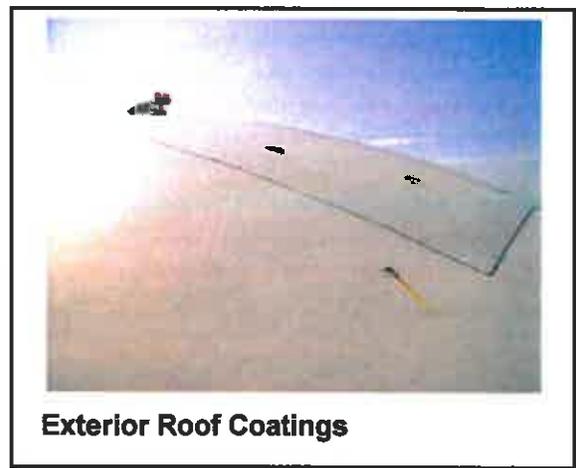
There is significant damage on tank sidewalls at the bottom of each pilaster. There are some coating failures on the exposed overflow pipe.
