REGULAR MEETING OF THE MUNICIPAL SERVICES COMMITTEE TO BE HELD ON MONDAY, OCTOBER 14, 2013, AT 6:00 P.M. AT THE VILLAGE HALL, 7760 QUINCY STREET, IN THE VILLAGE OF WILLOWBROOK, DUPAGE COUNTY, ILLINOIS.

## Executive Elevated Tank Observation Report

## 67th Street Elevated Tank Observation Report

## Standpipe Observation Report

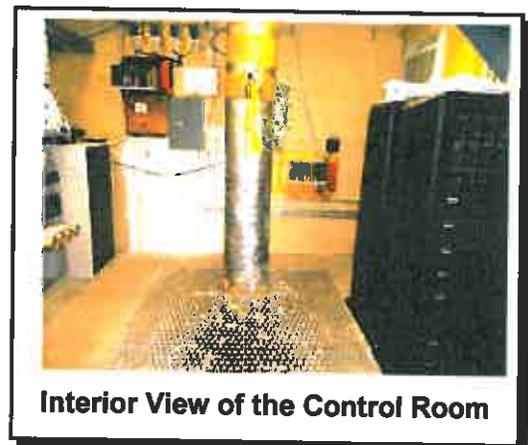
outlets. The water main pipe appears to be 12-inch diameter and enters the tower and vault from the south side. There is a fire extinguisher located outside the control room.

The actual valve vault pit located in the control room is 5 feet by 5 feet by 5 feet 8 inches deep. The valve vault pit houses a sump pump and expansion joint. The expansion joint appears to be in good condition. The base of the vault appears to be dry in some areas and damp in others. There is no visible condensation or standing water. The vault is secured by a steel/aluminum grating that was difficult to remove. There was no control valve observed on the piping. The pressure gauge on the riser pipe is a USA pressure gauge that read 54 psi. A WIKA cable communicates this reading to the supervisory control and data acquisition panel.

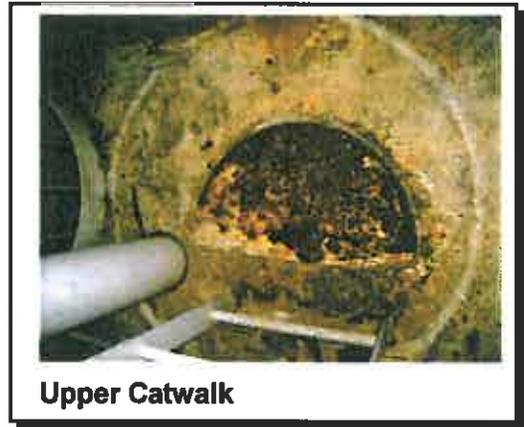
Upper Catwalk

The upper catwalk is in fair condition. The paint system appears to be failing and exhibits significant rust.

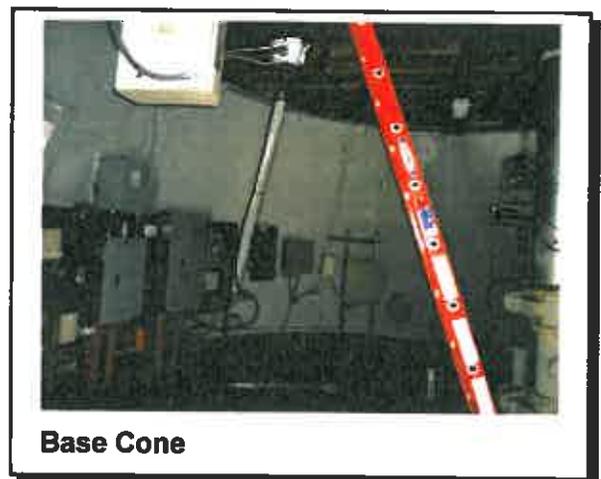
Base Cone

The exterior of the base cone had an average coating of 15 mils. There was small coating damage on the doors, apparently from the installation of the door switch. There

appears to be spot failure on the northwest and southeast side of the tank. An adhesion test of the exterior base cone resulted in a rating of 4, which is good adhesion.

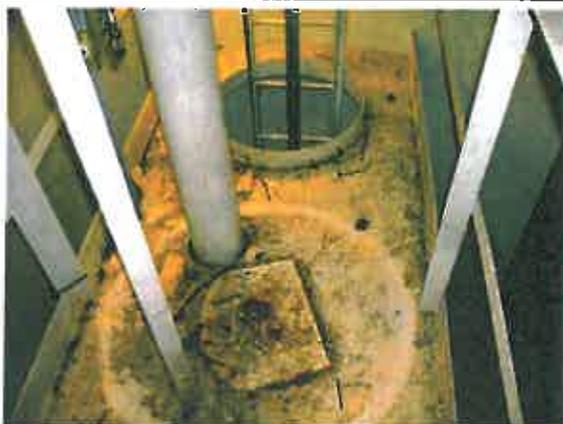
Upper Catwalk

The condensate platform appears in good condition. The hatch and manway show some corrosion and there is a rectangular weld seam (approximately 4 square feet) that has corrosion on both sides of the platform. The walls immediately above and below the platform are in good condition with very little or no corrosion visible.

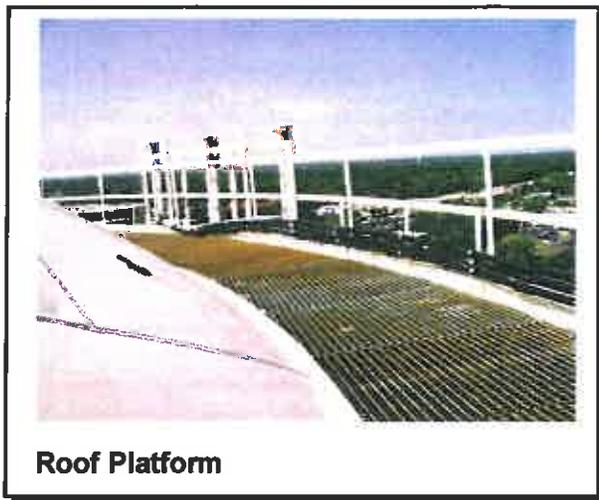
**Roof Platform**

There is a 4-foot-wide platform around the perimeter of the standpipe. There is a 42-inch-high handrail with toe plate, midrail, and top handrail.

The grating is unpainted but appears to be in good condition. The roof platform encompasses the tops of the five pilasters.
